REPOSITIONING THE LOWER THREAD GUIDE

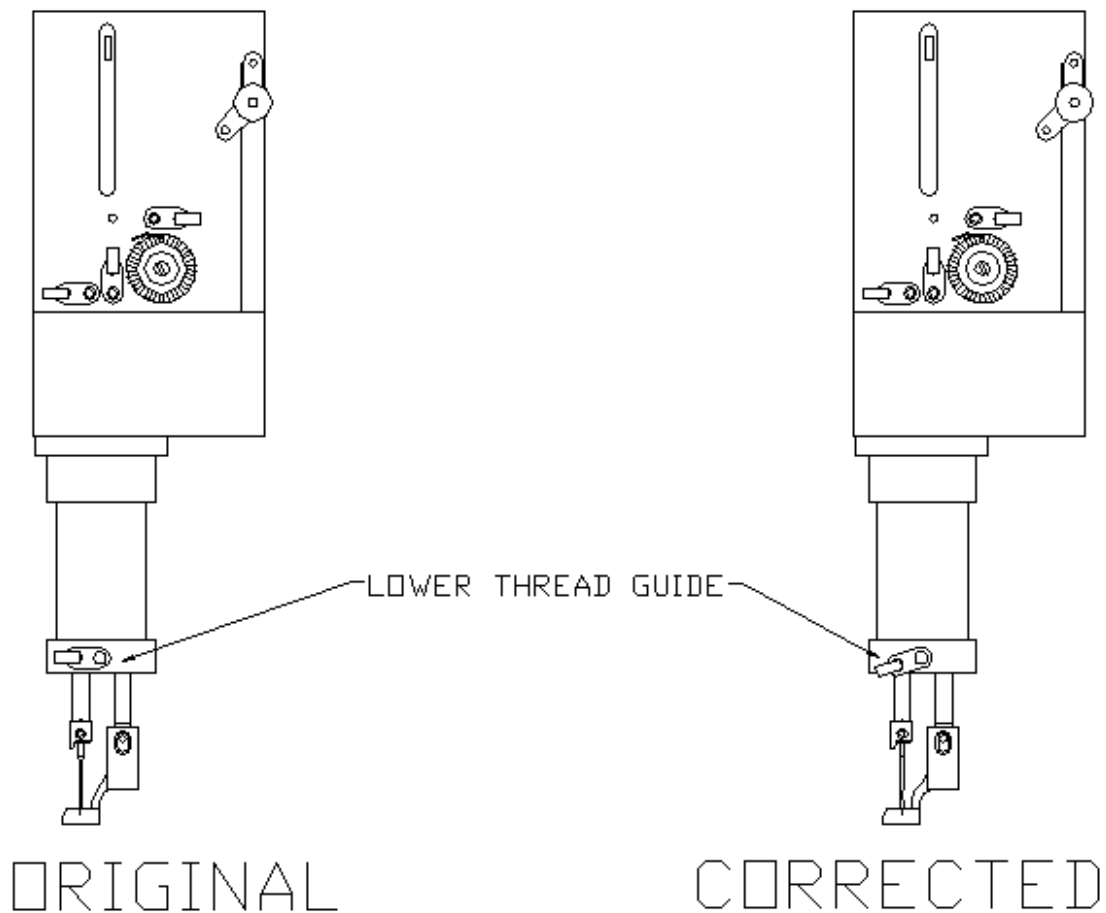
ABM International, with the help of Innova owners, has identified a significant problem with the position of the lower thread guide mounted on the Innova needle bar bushing. Originally, thread guides have been shipped in the horizontal or 9 o'clock position. This will cause the thread to rub on the lower edge of the aluminum needle bar bushing. Overtime, the thread will wear a groove into the bushing that can cause thread breakage. The groove does not affect the function of the needle bar, only the ability of the machine to sew reliably. All Innova owners are asked to inspect and remedy the problem. Loosen the thread guide screw and rotate the guide counter-clockwise to approximately the 8 o'clock position so that the thread will no longer rub on the aluminum bushing. See the illustration below.
